**Flood Control Project Maintenance  
Levee Inspections**

**Fall 2013 Levee Maintenance Deficiency Summary Report**

**Reclamation District No. 2060 Hastings**

**Levee Inspection Report By Mile - Fall 2013**

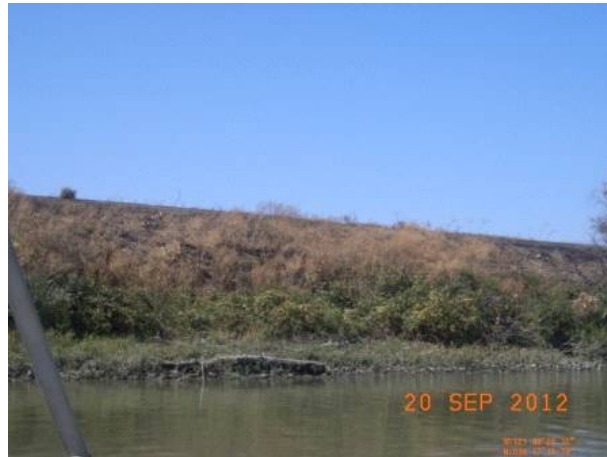
USACE 2012 Photo #2

Levee Mile Report Line	8
Start Levee Mile	1.55
End Levee Mile	1.70
Location	Water Side
Category	Supplemental
Item	USACE Erosion Survey

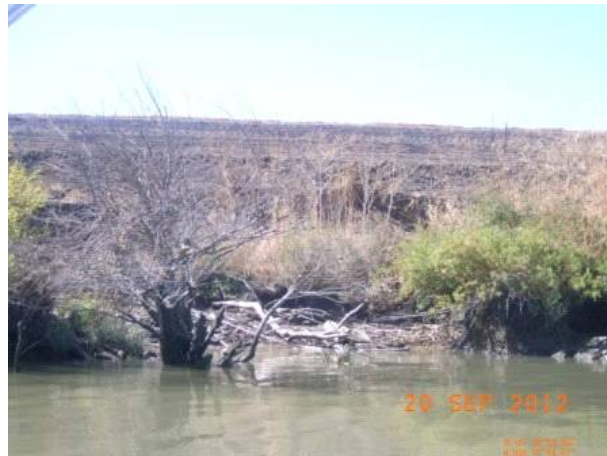
USACE 2012 Photo #1

Levee Mile Report Line	9
Start Levee Mile	2.02
End Levee Mile	2.08
Location	Water Side
Category	Supplemental
Item	USACE Erosion Survey

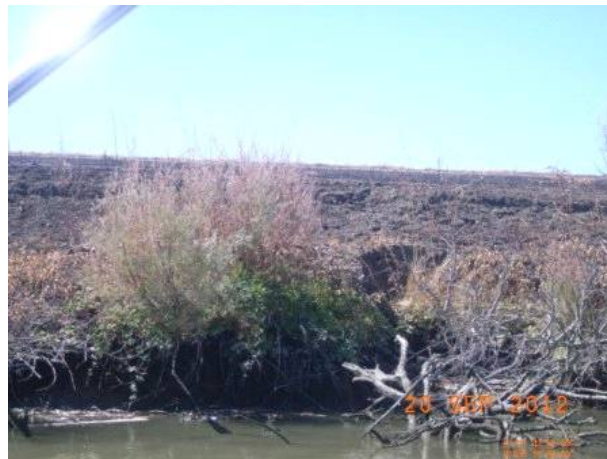
USACE 2012 Photo #1

Levee Mile Report Line	10
Start Levee Mile	2.18
End Levee Mile	2.23
Location	Water Side
Category	Supplemental
Item	USACE Erosion Survey

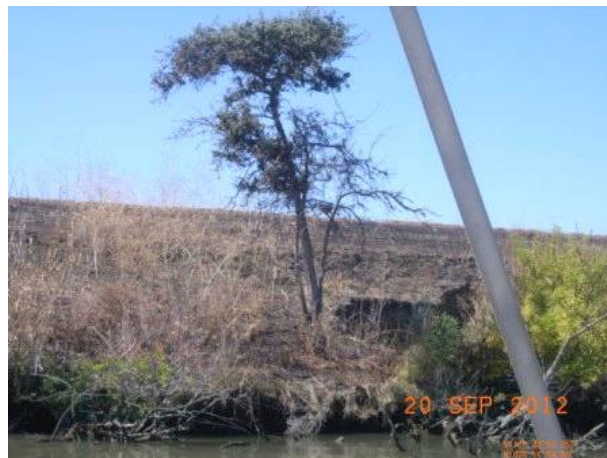
USACE 2012 Photo #2

Levee Mile Report Line	10
Start Levee Mile	2.18
End Levee Mile	2.23
Location	Water Side
Category	Supplemental
Item	USACE Erosion Survey

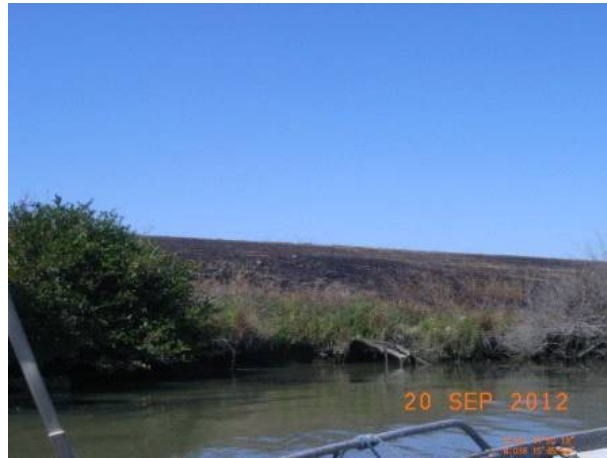
Levee Mile Report Line	19
Start Levee Mile	3.78
End Levee Mile	4.00
Location	Water Side
Category	Supplemental
Item	USACE Erosion Survey
USACE 2012 Photo #2	
USACE2013_CHS_21-1_R_2.jpg
